## The Washington National Cathedral

MATTHEW FARMER, PE | SENIOR PRINCIPAL  
WISS, JANNEY, ELSTNER ASSOCIATES, INC.

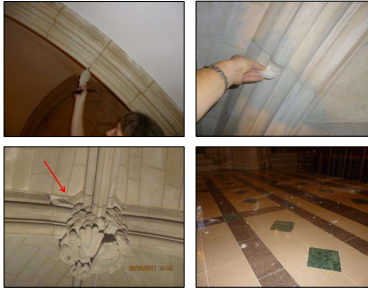
## Seismic Damage Interior

- Isolated Locations of Unstable Mortar
- Limestone Spalls
- Cracks in Boss Stone, Ribs, and Ceiling Interface

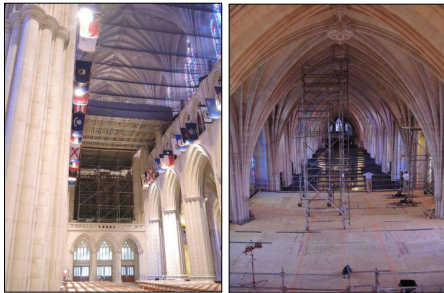
## Interior Stone Restoration

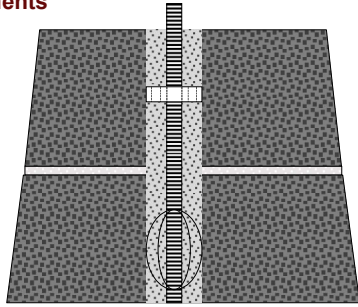
### Center Coring Components

- Core
- Reinforcement
- Centralizers
- Grout
  - Polyester Resin, Sand
  - Cementitious

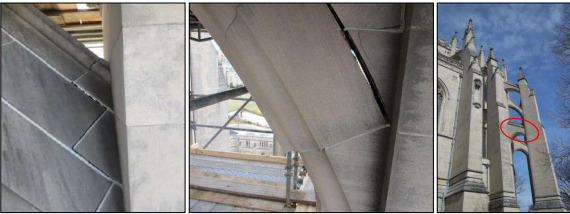
### Strengthening Apse Buttress Lower Flyer

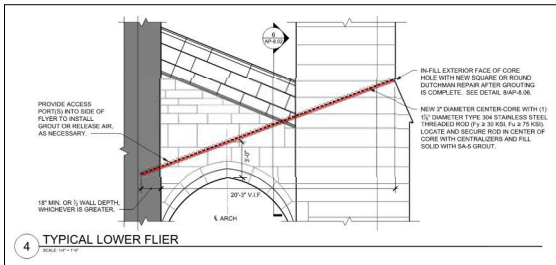
### Strengthening Apse Buttress Lower Flyer

4 TYPICAL LOWER FLIER  
SCALE: 1/4" = 1'-0"

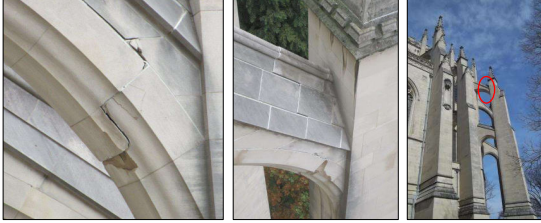
**Strengthening**  
Apse Buttress Upper Flyer

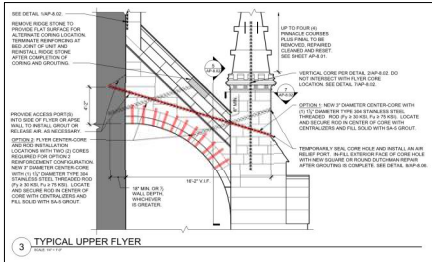
**Strengthening**  
Apse Buttress Upper Flyer

3 TYPICAL UPPER FLYER

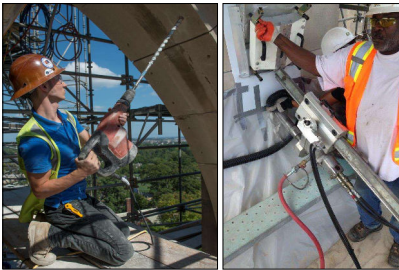
**Strengthening**  
Apse Buttress Upper Flyer

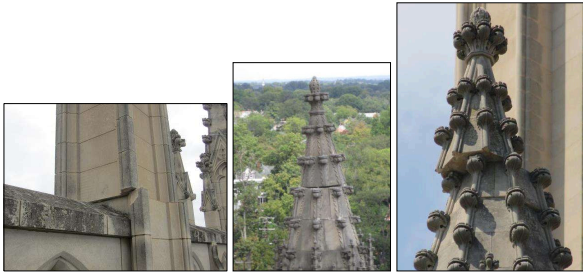
**Strengthening  
Pinnacles**

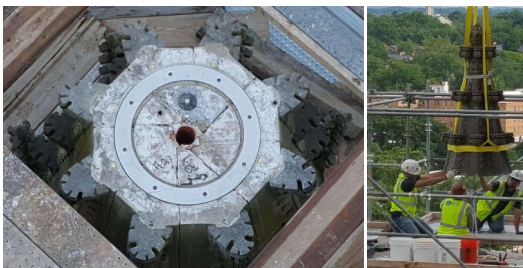
**Strengthening  
North Transept Turrets**

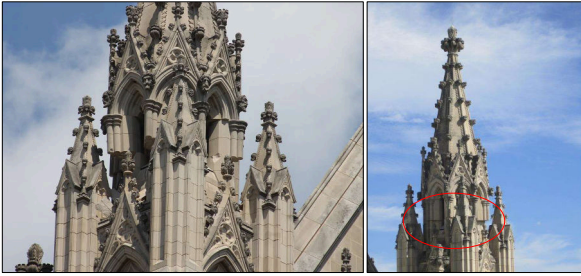
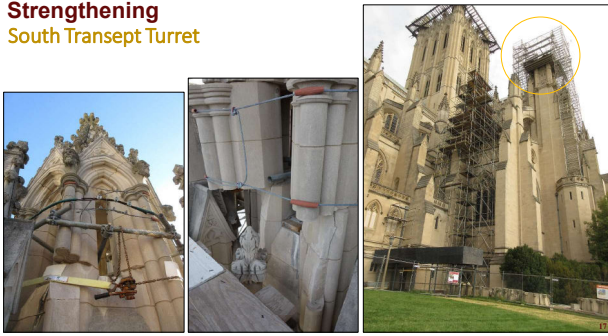
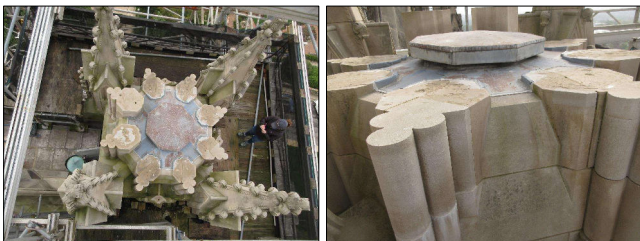
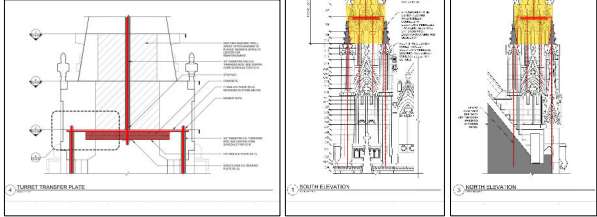
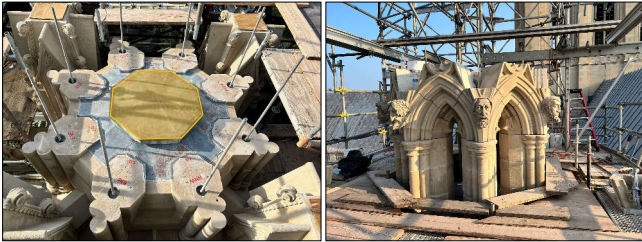
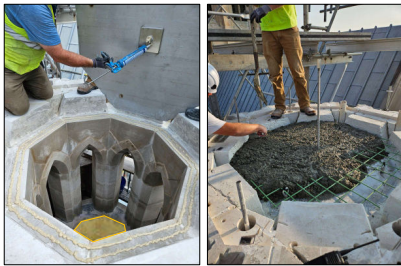
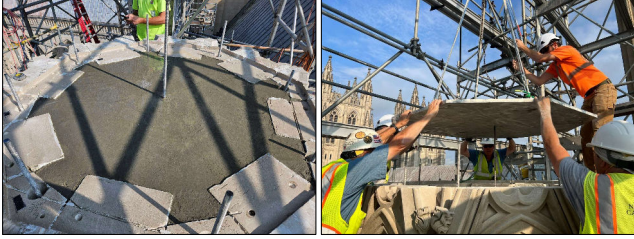
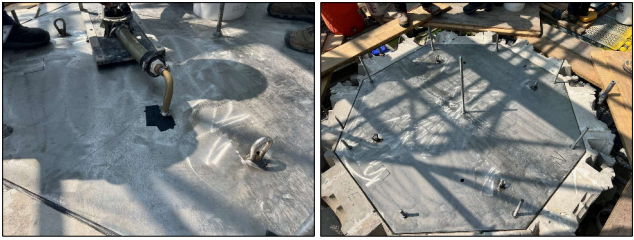
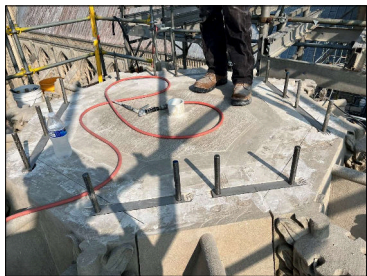
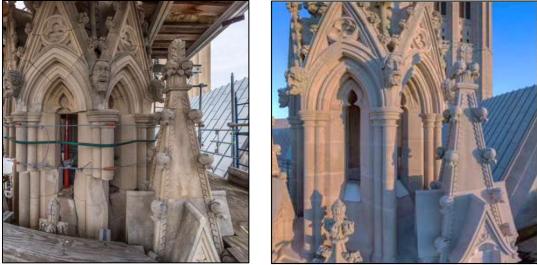
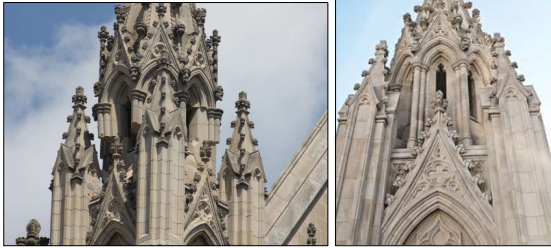
**Strengthening**  
South Transept Turret

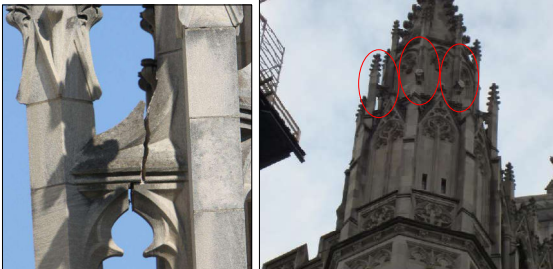
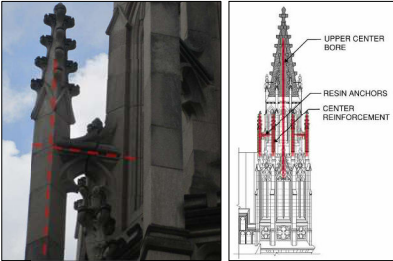
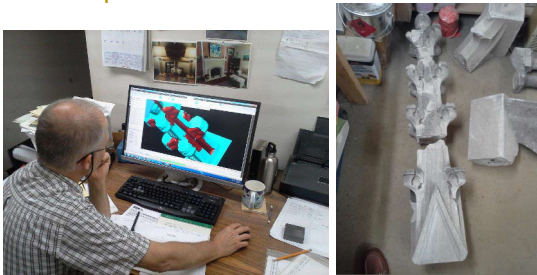
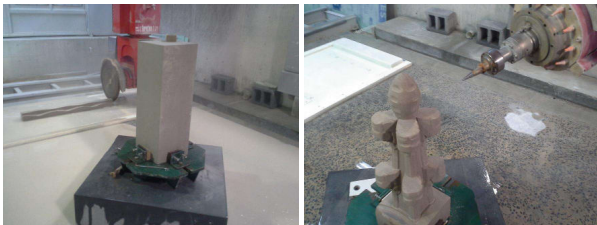
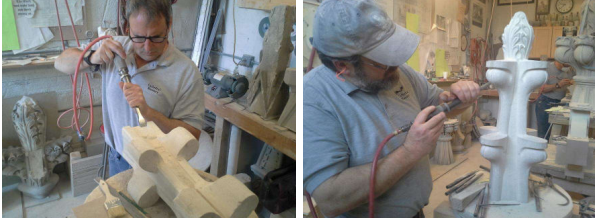
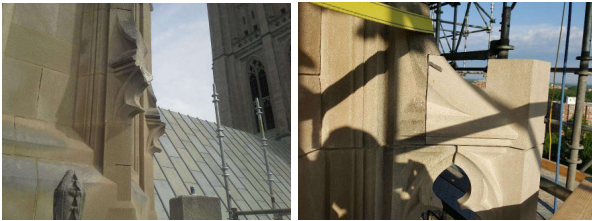
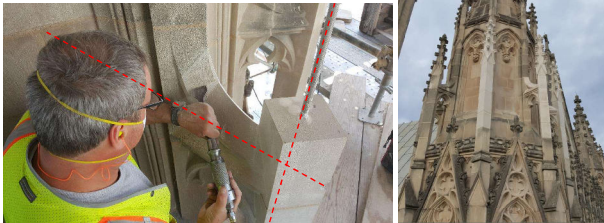
**Stone Restoration**  
North Transept Turrets

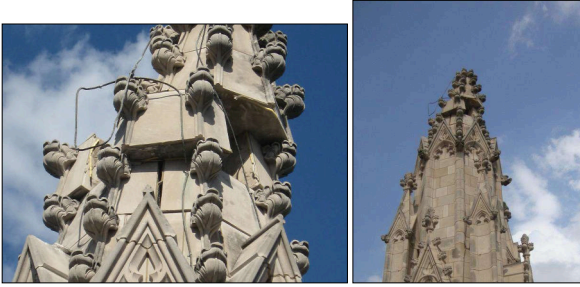
**Stone Restoration**  
Central Tower Grand Pinnacles
